THE LONG-TERM PERFORMANCE OF PERVIOUS PAVING

Steve Crossland, Stuart Girvan, Firth Industries Ltd

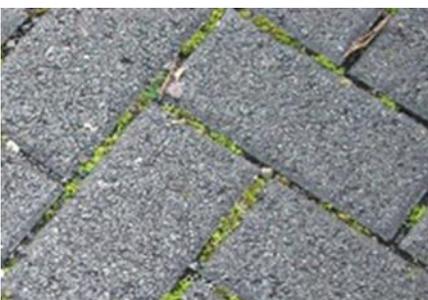
Photo 6: Before cleaning.

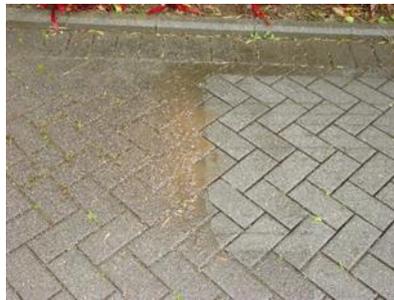
Photo 7: During cleaning

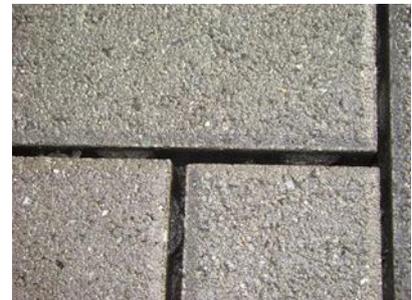
Photo 8: After cleaning, before rechip.

After cleaning the Porous Gaps and Porous Blocks the joints are refilled with a 2/7mm chip (Porous Gaps) or a clean sand (Porous Blocks) and vibrated with a plate compactor.

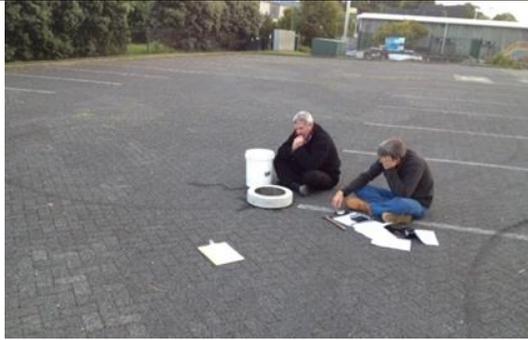
North Shore Events Centre, Parking Area

- Tested 2006 ⁽¹⁾	2 years	500 (sediment); 7,400; 2,900		
- Tested 2014 ⁽⁵⁾	10 years	640 (weeds); 4,200 (no weeds)		
- Tested 2016 ⁽⁴⁾	12 years	290 (weeds)	1,100

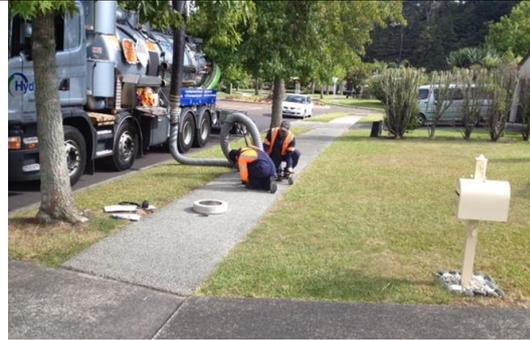
- Birkdale Road, Parking Bay ⁽⁴⁾	2010 – 6 years	430	1,260	
Porous Concrete				
- Clemow's Lane, Footpath	2010			
- Under Tree, near driveway				
- Tested 2010 ⁽⁹⁾ (As-built)	0 years	6,700

- Tested 2014 ⁽⁶⁾	4 years	330

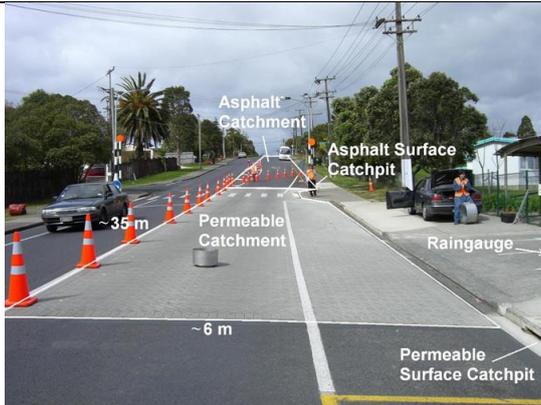
Birkdale Road, Traffic Lane and Parking Bay

- To minimise joint filler loss Firth Ltd are trialing a water based acrylic joint stabiliser solution with initial good results.
- The worst performing was the Birkdale Road traffic lane trial on a local road with significant traffic loads (on a bus route) where the Porous Blocks have experienced 'high' depressions, joint filler loss and damaged pavers, along with 'medium' rutting and joint widths. In contrast, the adjacent parking bay has performed well with all 'low' severity performance. The Birkdale Road was a trial to test the performance of the pervious surface to significant traffic loads and reinforces the recommended design practice of restricting pervious paving for parking areas and driveways.

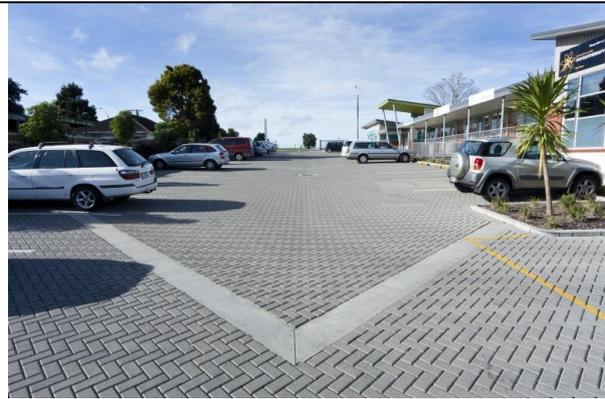
Te Atatu Medical Centre, Parking

- Earthsong Ranui Parking ⁽⁴⁾	2008 – 8yrs	1,000 ⁽⁸⁾	1,600	
- Te Atatu Medical Centre Parking ⁽⁴⁾	2009 – 7yrs	1,800	11,000	
Porous Blocks				
- North Shore Events Centre, Parking	2004

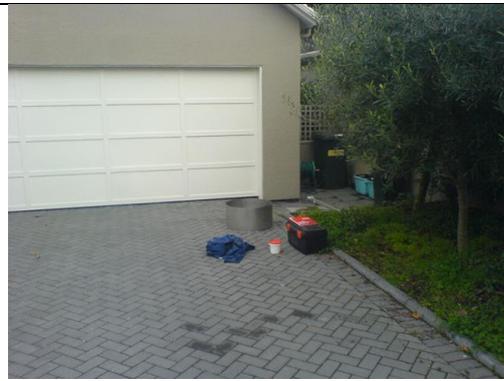
Upland Road, Driveway

- Upland Road Driveway	2004			
- Tested 2006 ⁽¹⁾	2 years	2,700; 4,200		
- Tested 2007 ⁽¹⁾	3 years	4,400		
- Tested 2014 ⁽²⁾	10 years	310		
- Tested 2016 ⁽³⁾	12 years	N/A	12,600
