# Fire-resistance test on sealing systems protecting service penetrations and control joints in concrete walls

**Test Report**

Author: Chris Wojcik Report number: FSP 1839

Date: 20 July 2017

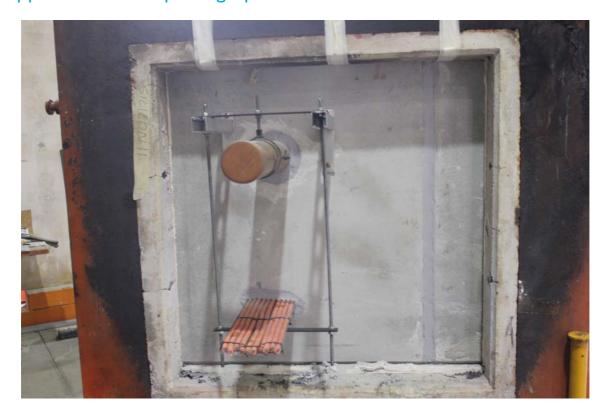
PHOTOGRAPH 1 – EXPOSED FACE OF THE SPECIMENS PRIOR TO TEST

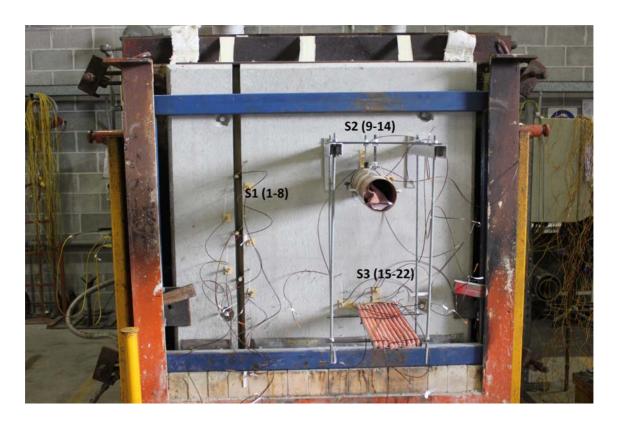
PHOTOGRAPH 2 – UNEXPOSED FACE OF THE SPECIMENS PRIOR TO TESTING

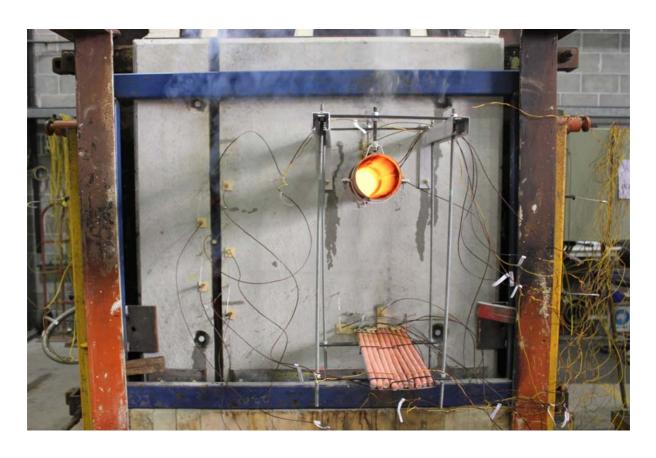
22 minutes - Glow is visible inside the joint of Specimen 1, at approximately ¾ height.

28 minutes - <u>Insulation failure of Specimen 1</u> – maximum temperature rise of 180 deg C is exceeded on the unexposed face of the backing rod.

PHOTOGRAPH 3 – SPECIMENS AT 30 MINUTES INTO THE TEST

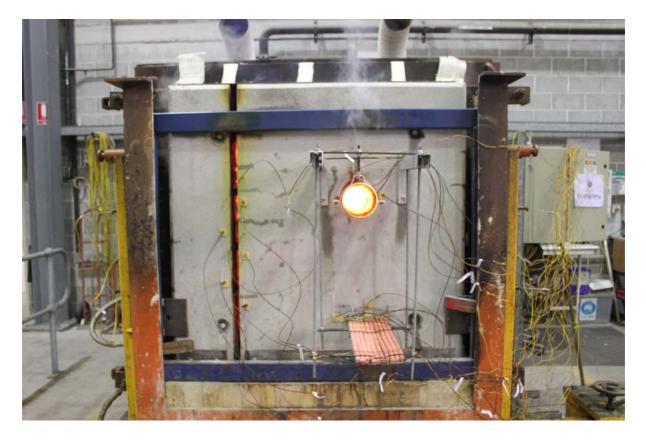
38 minutes - Some sealant from around the pipe of Specimen 2 is starting to fall off

58 minutes - Cotton pad test applied over the glow noted at 22 minutes – no ignition of cotton noted.

PHOTOGRAPH 4 – SPECIMENS AT 60 MINUTES INTO THE TEST

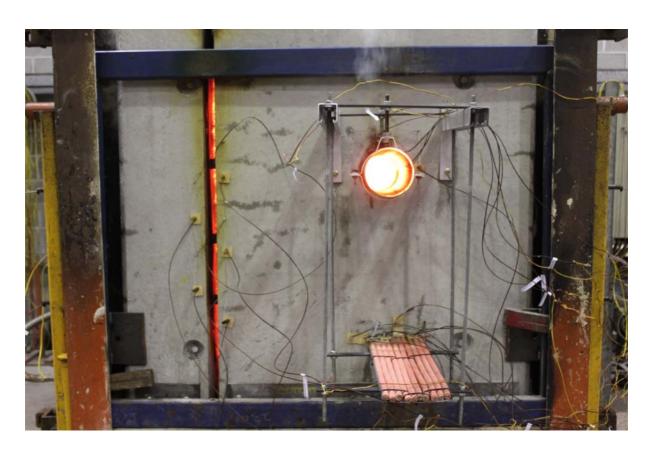
113 minutes - Sealant around the pipe of Specimen 2 is starting to discolour/char, pipe has subsided within the penetration opening.

PHOTOGRAPH 5 – SPECIMENS AT 120 MINUTES INTO THE TEST

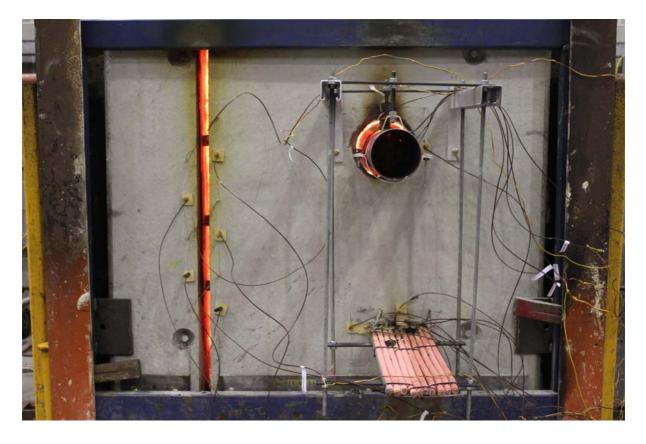
134 minutes - End cap from the pipe of Specimen 2 has melted.

140 minutes - <u>Integrity failure of Specimen 2</u> - copper pipe has started to melt at the base of penetration, ceramic fibre plug is inserted into the pipe

145 minutes - <u>Insulation failure of Specimen 3</u> – maximum temperature rise of 180 deg C is exceeded on the unexposed face of the cables.

PHOTOGRAPH 6 – SPECIMENS AT 180 MINUTES INTO THE TEST

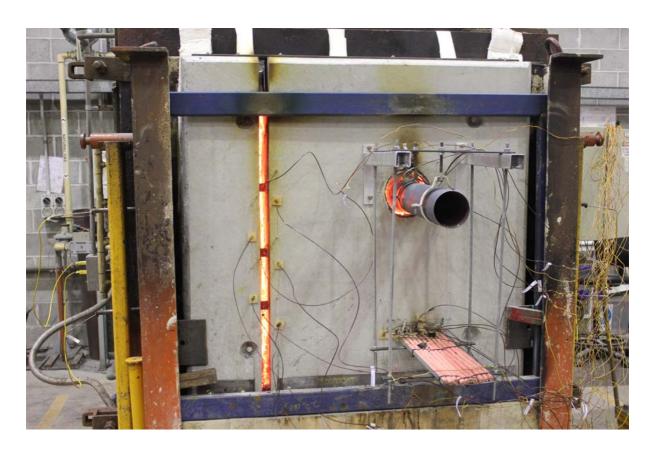
PHOTOGRAPH 7 – SPECIMENS AT THE CONCLUSION OF TESTING

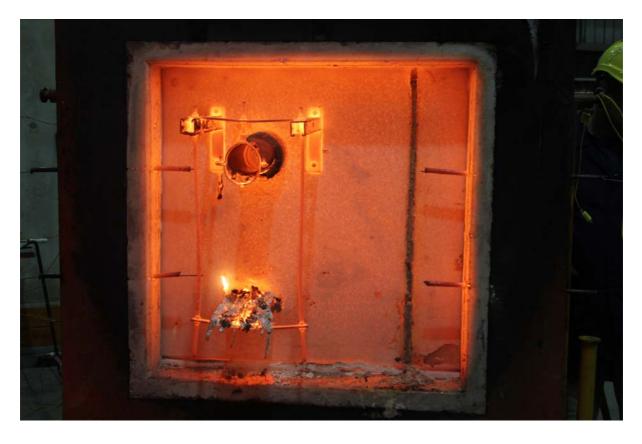
PHOTOGRAPH 8 – EXPOSED FACE OF THE SPECIMEN AFTER THE CONCLUSION OF TESTING

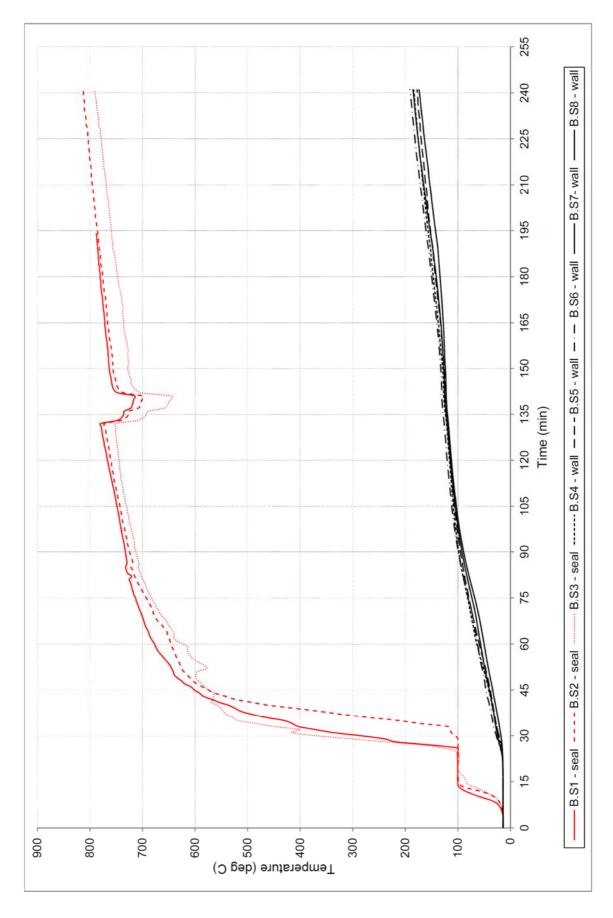
Figure 3 shows curves of temperature versus time recorded on the unexposed face of Specimen 1.

FIGURE 3 – SPECIMEN TEMPERATURE – UNEXPOSED FACE OF SPECIMEN 1

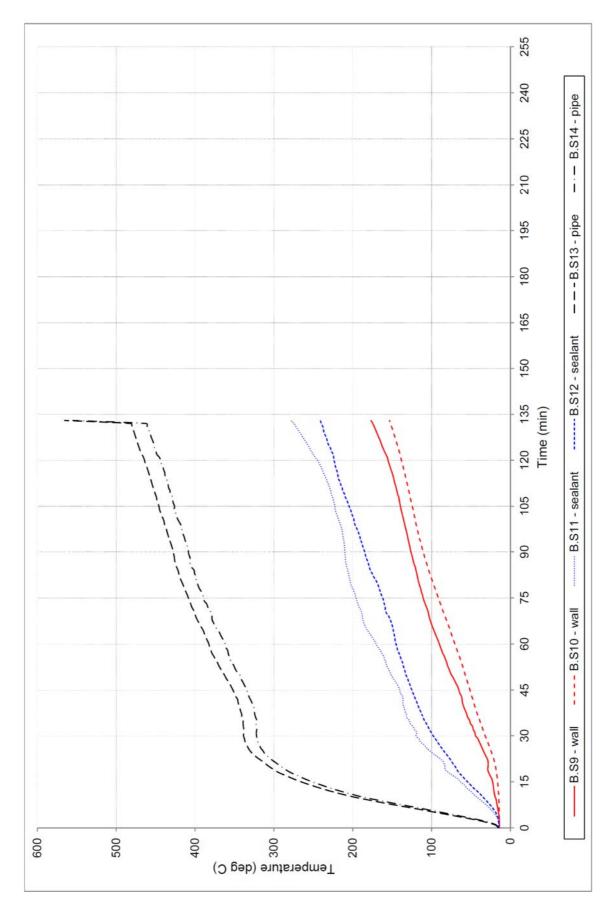
10 minutes - <u>Insulation failure of Specimen 2</u> – maximum temperature rise of 180 deg C is exceeded on the unexposed face of the pipe.

Figure 4 shows curves of temperature versus time recorded on the unexposed face of Specimen 2.

FIGURE 4 – SPECIMEN TEMPERATURE – UNEXPOSED FACE OF SPECIMEN 2

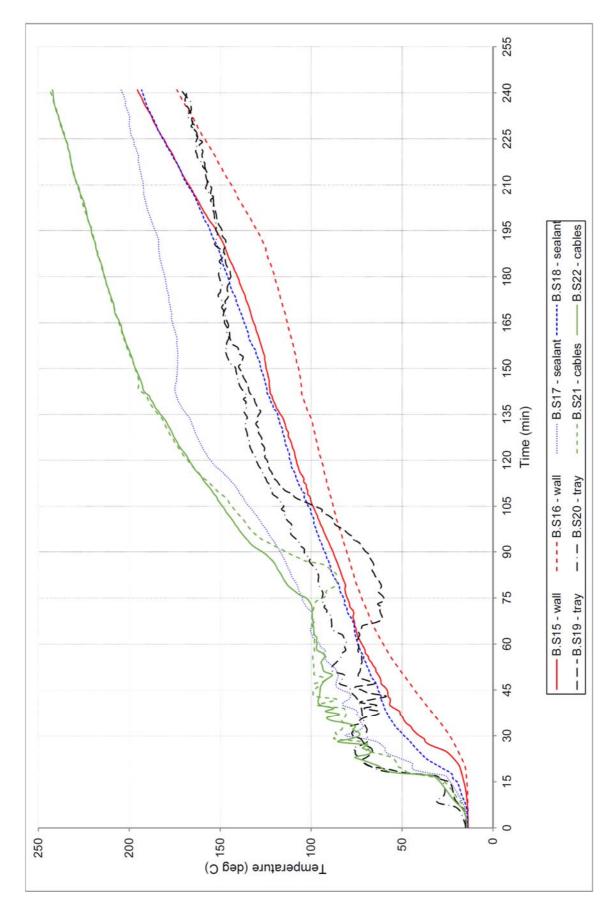
Figure 5 shows curves of temperature versus time recorded on the unexposed face of Specimen 3.

FIGURE 5 – SPECIMEN TEMPERATURE – UNEXPOSED FACE OF SPECIMEN 3
