THE LONG-TERM PERFORMANCE OF PERVIOUS PAVING

Steve Crossland, Stuart Girvan, Firth Industries Ltd

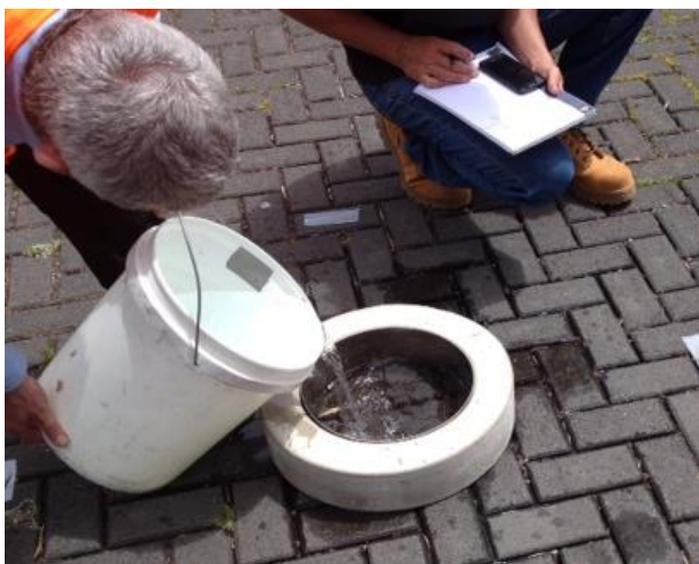
Photo 1: Timing a set volume of water, at a constant depth of 10 to 15mm, to infiltrate the pervious surface within the steel ring. Concrete surround (with a soft closed cell foam on its base, see photos 2 and 3) provides a seal to

minimise horizontal leakage from under the inside ring.

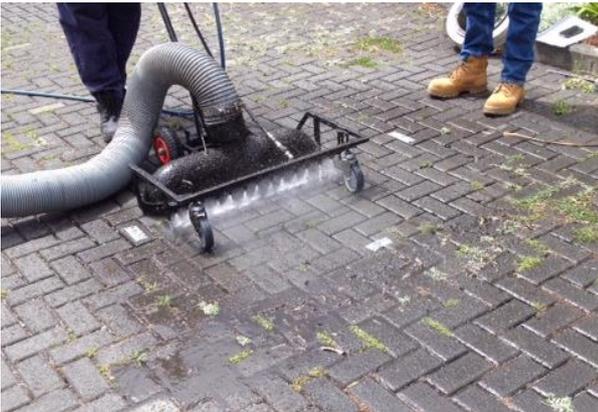
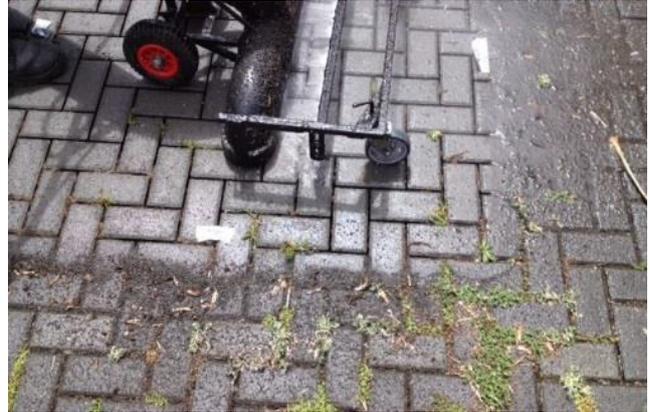
Photos 4 (left) and 5 (right): Cleaning the pervious surface. The thirteen, 1,000 psi water jets dislodge the sediments/moss/weeds from the surface and in the joints, which are then picked up with the vacuum suction. Most weeds are dislodged and vacuumed up but some weeds with long roots remain and need to be hand plucked.
