1 d - Typical Horizontal Joint with Weatherboard - Direct Fixed to framing

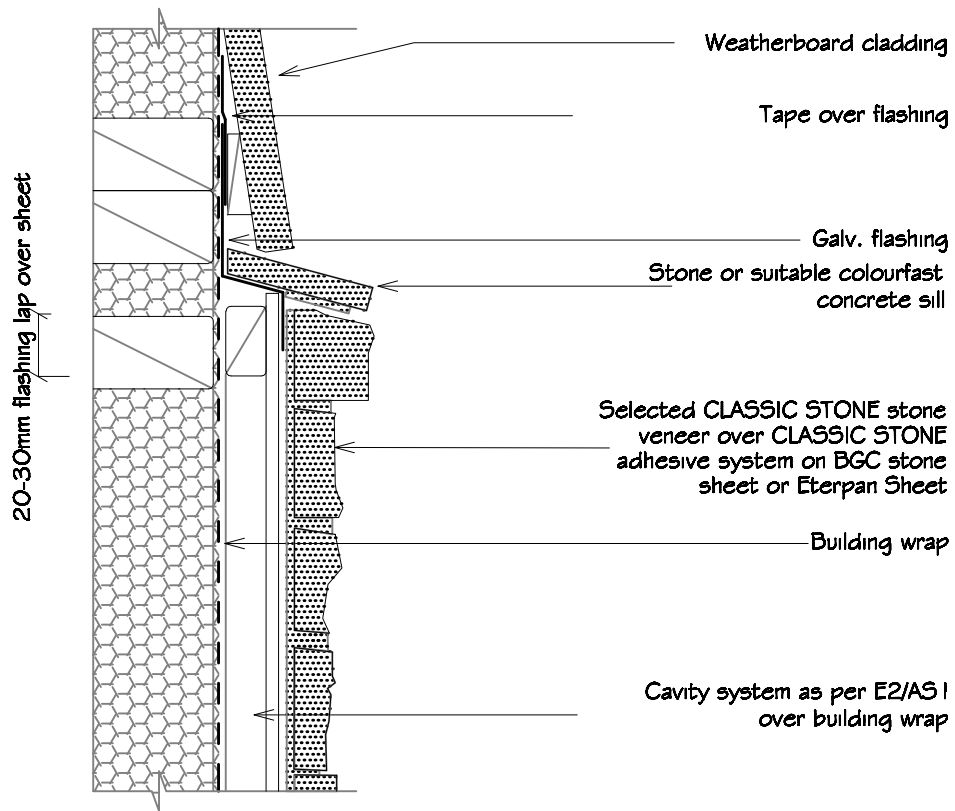
Alternative Sill Detail
